MHS SEALS

O-RING FAILURE ANALYSIS

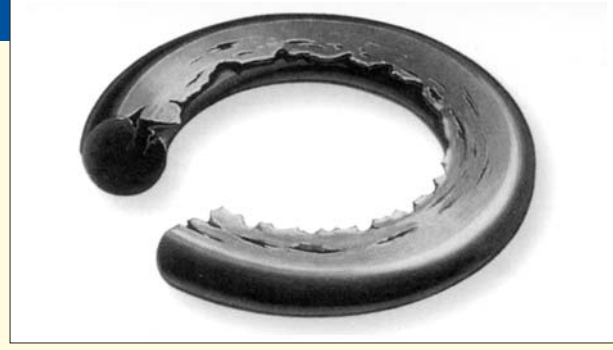
EXTRUSION OR NIBBLING

The seal develops ragged edges, generally on the low pressure side, which appear tattered. This condition is more common with high pressure systems

- Excessive clearances
- Excessive system pressure
- Irregular clearance gaps due to eccentricity
- Sharp groove edges
- Low-modulus/low-hardness elastomer
- Softening of elastomer due to fluid incompatibility
- Excessive gland fill
- Expansion of cylinder wall due to pressure

- Decrease clearances
- Decrease system pressure if possible
- Use back-up ring
- Increase rigidity and concentricity of metal components
- Break edges of groove to minimum of .004" (0.10mm)
- Use higher-modulus/higher-hardness elastomer
- Use more chemically compatible elastomer
- Increase groove width or change o-ring size
- Stiffen cylinder wall to limit expansion

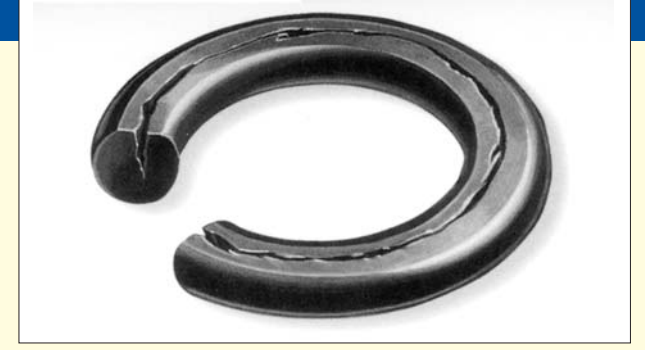
OVER-COMPRESSION

The seal exhibits parallel flat surfaces corresponding to the sealing surfaces. May also develop circumferential splits within flattened surfaces.

- Excessive compression squeeze
- Elastomer with poor compression set properties
- Elastomer with inadequate heat resistance
- Elastomer that swells excessively in system fluid
- Improperly cured part used

- Use smaller o-ring or adjust gland dimensions
- Use material with better compression set resistance
- Use more heat resistant elastomer
- Use more chemically resistant elastomer
- Check cure state of parts prior to installation

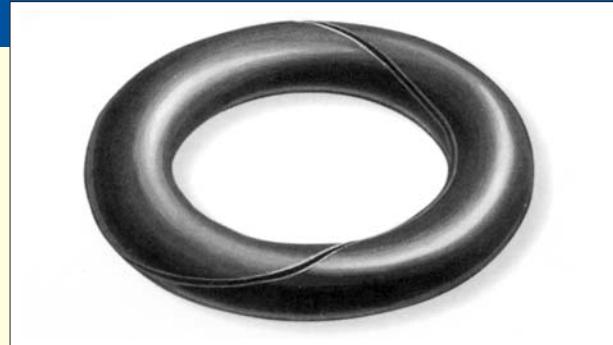
SPIRAL FAILURE

The seal surface exhibits a series of deep, spiral, 45° angle cuts. This failure is often seen with long-stroke, hydraulic piston seals.

- Eccentric components
- Wide clearances in combination with side locks
- Uneven surface finishes
- Inadequate lubrication
- Elastomer is too soft
- Stroke speed too slow - dynamic reciprocating

- Increase rigidity and concentricity of metal components
- Decrease clearances
- Machine metal surfaces to 10 to 20 pinch surface finish
- Specify an external lubricant or use an internally lubricated material
- Use a higher durometer material
- Increase stroke speed or use D-ring instead of O-ring

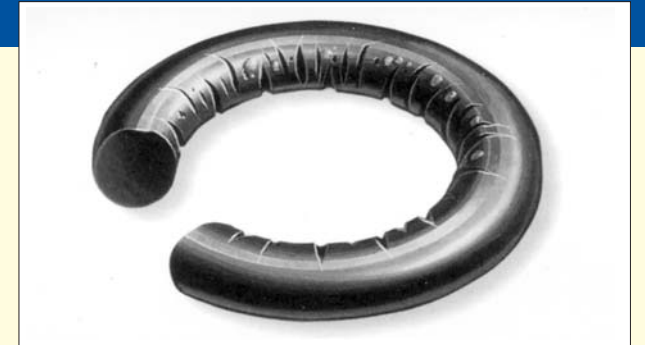
HEAT HARDENING/THERMAL DEGRADATION

The seal may exhibit radial cracking on the highest temperature surfaces, often accompanied by the flattening of the seal characteristics of over-compression. Certain elastomers may exhibit signs of softening, such as a shiny surface.

- Thermal properties of elastomer
- Excessive temperatures, temperature excursions or temperature cycling

- Select more heat-resistant elastomer
- Select elastomer containing antioxidants
- Consider possibility of cooling sealing surfaces
- Increase thermal mass to dampen temperature cycling or excursions
- Change the position of the gland away from heat source

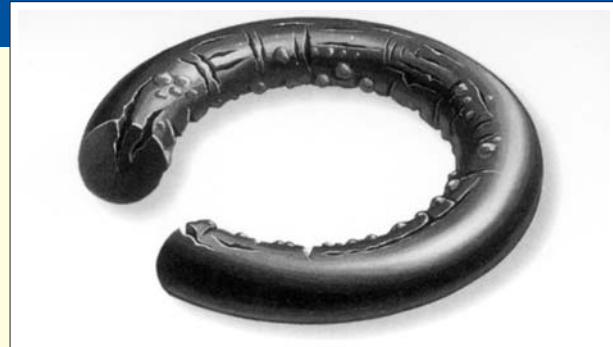
EXPLOSIVE DECOMPRESSION

Explosive decompression results when high-pressure gases are absorbed by the seal, and then, as the pressure is rapidly dropped, the expanding gases are trapped in the micropores of the elastomer, causing surface blisters and ruptures as they escape. The effected seals will exhibit random short splits or ruptures deep into the seal cross-section. When first removed the surface may also be covered with small blisters.

- Rapid pressure drop from high pressure
- Low-modulus/low-hardness elastomer

- Slow the release of system pressure
- Specify a higher-modulus/higher-hardness material
- Specify a decompression-resistant material

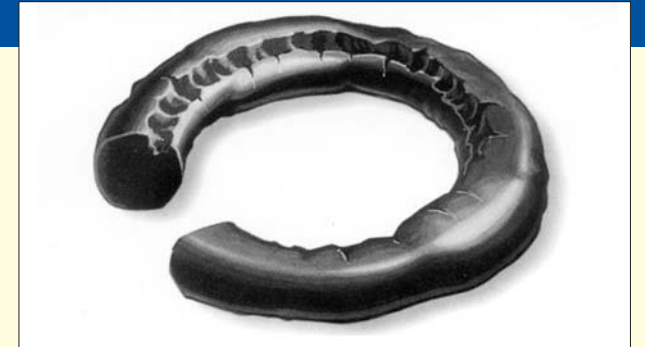
CHEMICAL DEGRADATION

The seal may exhibit many signs of degradation including blisters, cracks, voids, or discoloration. However, in some cases the degradation is only detectable by measurement of physical properties.

- Incompatibility with chemical environment

- Use more chemically resistant elastomer
- Use PTFE encapsulated o-ring
- Decrease temperature that o-rings sees, as higher temperatures accelerate chemical degradation

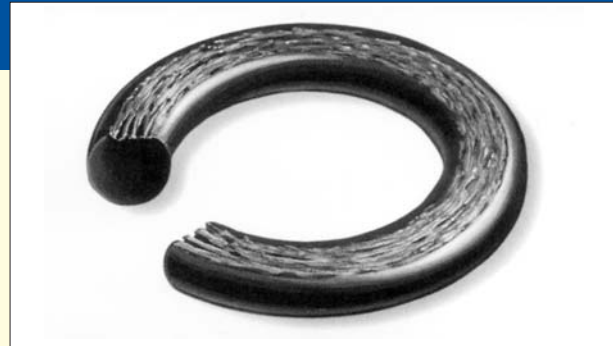
ABRASION

Abrasion occurs only with dynamic seals - seals involved with a rotary, oscillating or reciprocating motion. The seal or parts of the seal exhibit a single flat surface parallel to the direction of motion. Loose particles and scrapes may be found on the seal surface.

- Rough sealing surface
- Sealing surfaces too smooth to allow for adequate lubrication
- Process environment containing abrasive particles

- Use recommended gland surface finishes
- Use recommended gland surface finishes
- Eliminate abrasive components or protect seal from exposure to them

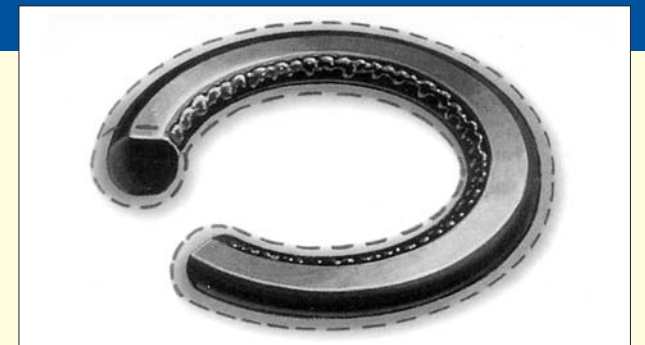
PLASTICIZER EXTRACTION

Seen primarily in fuel systems, plasticizer extraction is characterised by a loss of volume or weight of the seal. It is often difficult to detect with only a visual inspection.

- Heavy use of plasticizers to achieve low-temperature properties or hardness
- Exposure to organic solvents compatible with plasticizers used

- Switch to elastomer with low-temperature properties so plasticizers aren't needed
- Change plasticizers used to ones less compatible with process fluids

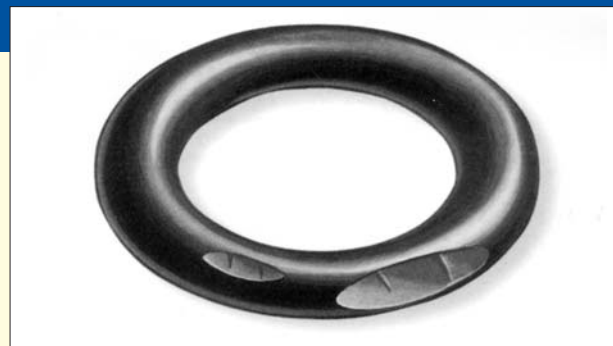
INSTALLATION DAMAGE

The seal or parts of the seal may exhibit small cuts, nicks or gashes.

- Sharp surfaces on glands or components
- Inadequate lead-in chamfer
- O-ring too large for gland
- Low-modulus/low-hardness elastomer

- Break all sharp metal edges and cover threads with tubes or tape for installation
- Provides a 15° lead-in chamfer of adequate length so o-ring sees only chamfer
- Review gland and o-ring design per recommended design standards
- Specify a higher-modulus/higher-hardness material

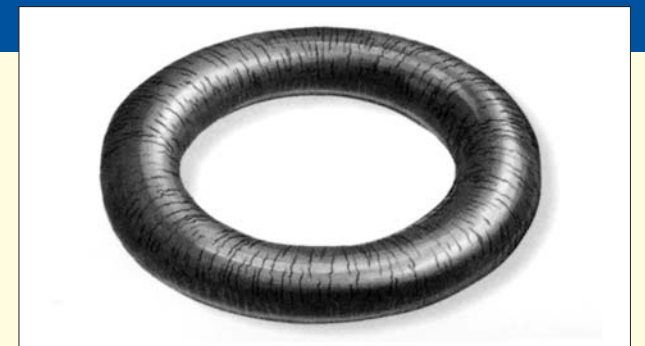
WEATHER OR OZONE CRACKING

Occurring in seals exposed to ozone, UV radiation or other air pollutants, weather or ozone cracking is characterised by small surface cracks perpendicular to the direction of stress.

- Exposure to ozone, UV radiation or other pollutants
- Excessive seal stretch (>5% ID stretch)

- Select more ozone and UV-resistant elastomer
- Apply anti-ozonant or wax coating to seal
- Modify the design to avoid the damaging exposure
- Modify design to reduce stretch to less than 5%
